**Touching The Tide Project Report**  
**Dunwich Marine Archaeology Survey**

Professor David Sear

Department of Geography & Environment  
University of Southampton  
2015

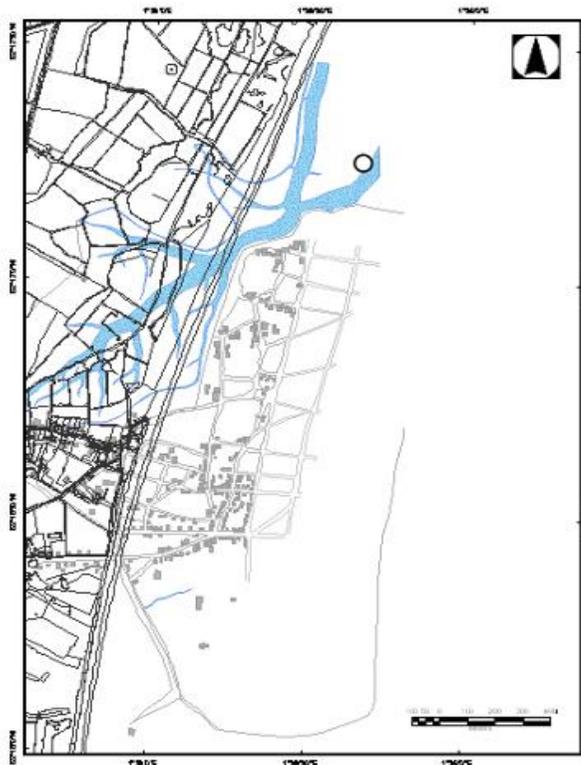
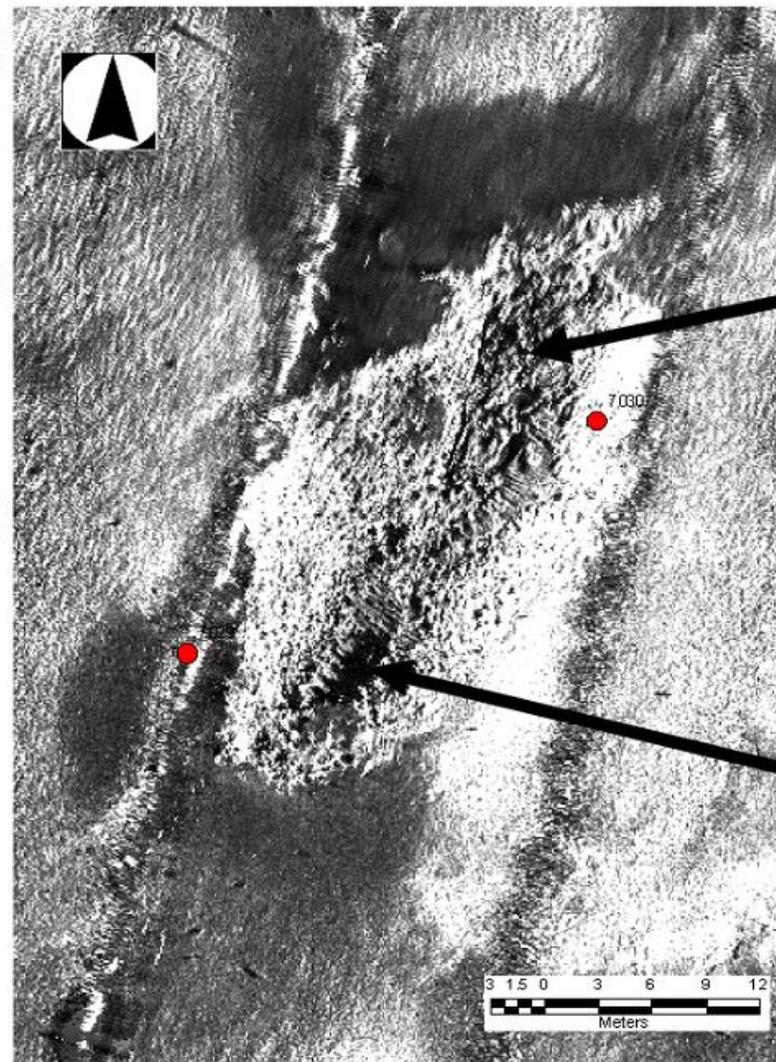
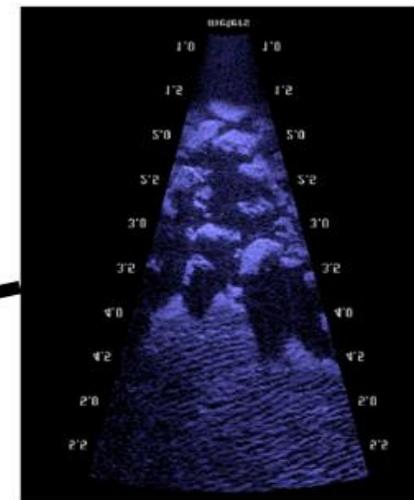
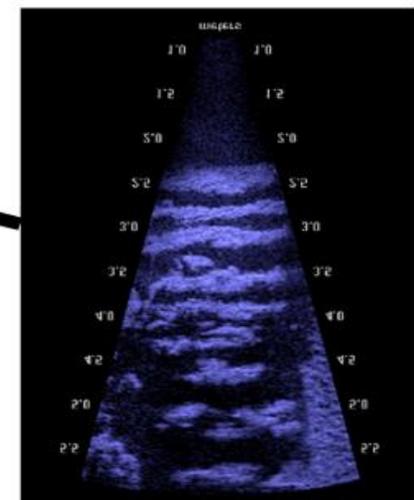
**Figure 5:** Target 1 Wreck site showing its position adjacent to the former Dunwich/Blyth river north of the old port and harbour area. Central panel shows Wessex Archaeology 2009 Sidescan sonar image with areas of possible wooden ribs of posts and areas of rubble shown. Red dots refer to magnetometer anomalies suggesting the presence of ferrous metal. Right hand images show DIDSON-DH 15m images of the Ribs and what is interpreted as stone ballast.

The site proved to be a shipwreck. In the DIDSON-DH images (Figure 5, Appendix 2.0), the diver could see the ribs of a wooden vessel, with piles of stone ballast lying in between each rib and in a pile on the landward side. The pile of ballast probably results from the ship leaning to landward as it was driven onto the sand bank or beach during a storm.

The diver acting on experience, felt around one of ribs, and recovered a small (5cm x 2cm) strip of thin copper sheathing. Copper sheathing was only common on merchant ships after c.1800 AD, and in Royal Navy ships after 1780AD. Muntz metal sheathing (an alloy of zinc and copper) became widespread after 1840. On this basis we suggest a date for the wreck post 1800AD. This date precludes the vessel being associated with the old Dunwich/Blyth river. Rather the location suggests it was driven on to the inner and bank which parallels the beach, at some point in the 19<sup>th</sup> century.

- A large, new unidentified wreck dating from the late 18<sup>th</sup> or 19<sup>th</sup> century has been found to the north of the harbour area of the old town of Dunwich. The wreck was exposed at time of survey and shows evidence of copper sheathing, wooden ribs, and ballast or possible cargo stones. A more detailed investigation of the wreck is warranted, focussing on the

precise metal used in the sheathing which would help date the wreck, together with a sample of the stone for confirmation of ballast or cargo. Local historical societies should be involved in identifying the vessel.

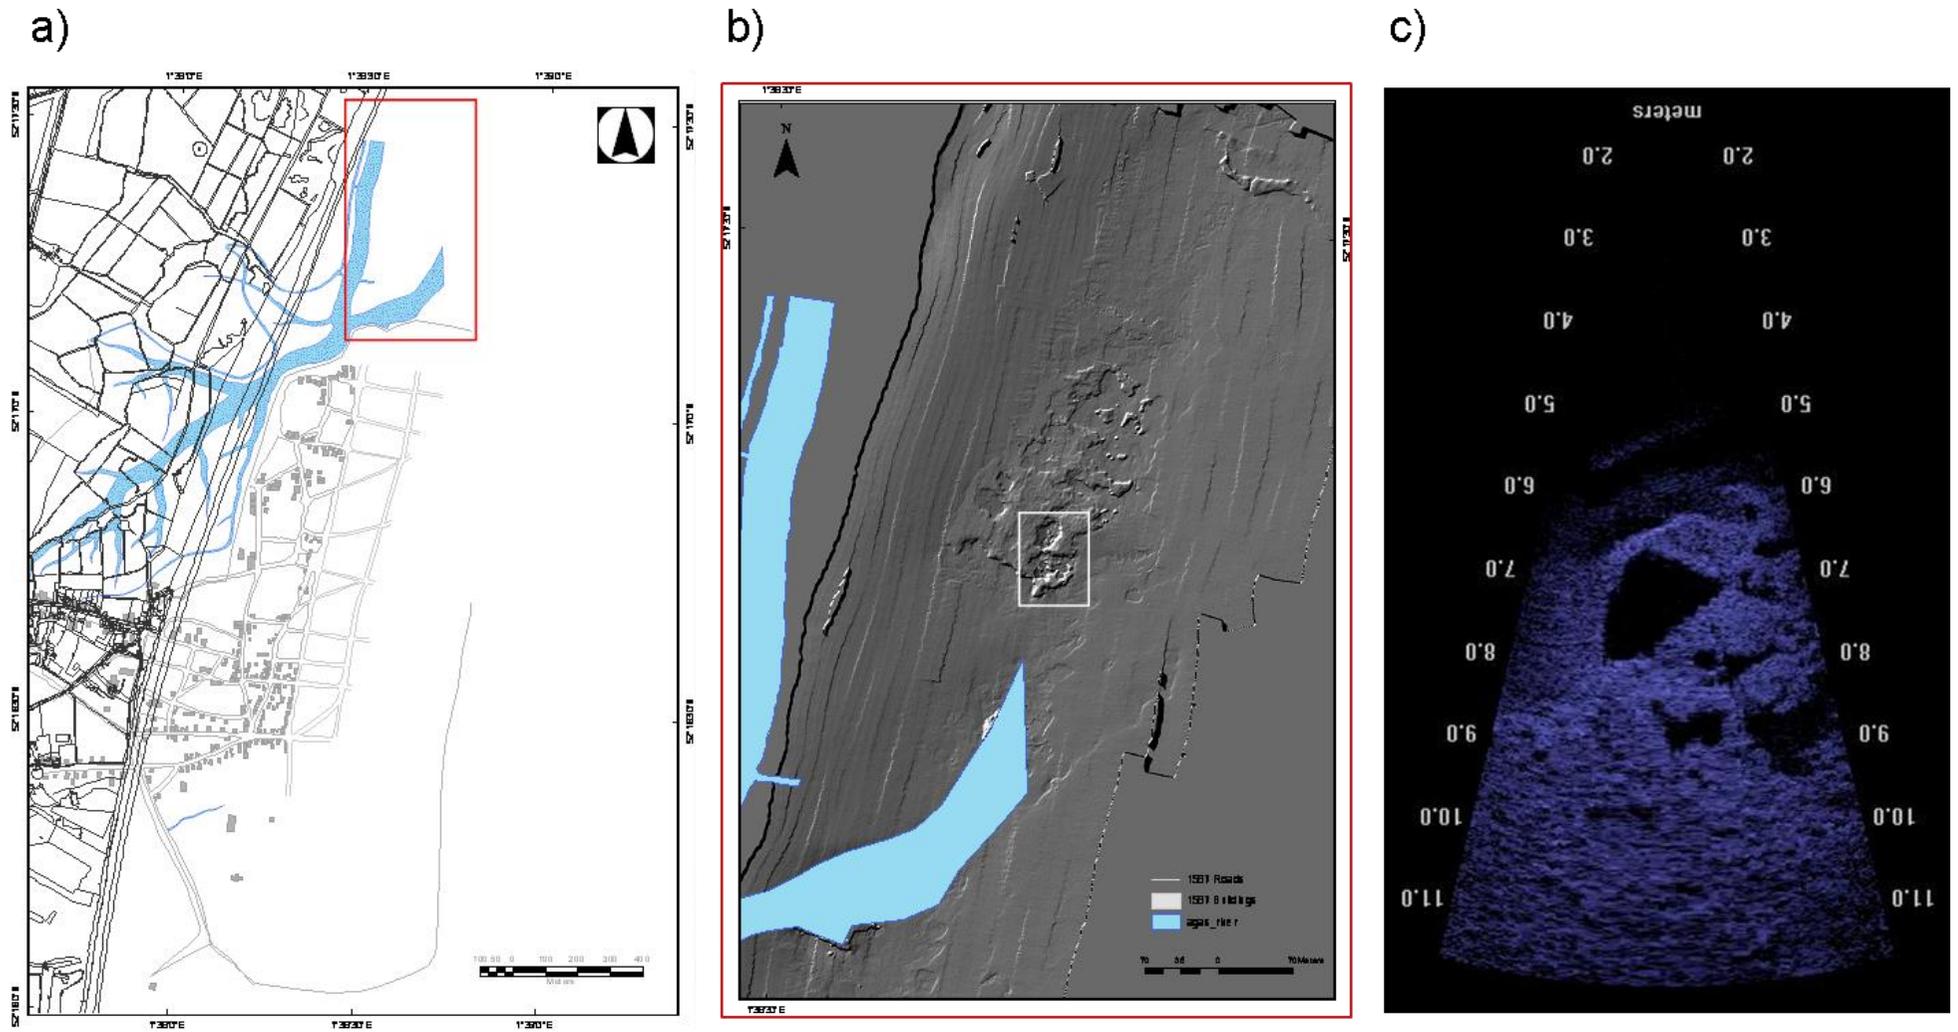
The second target dived was a potential area of ruins located north of the harbour area (Figure 6a,b). DIDSON images revealed flat faced blocks which visually looked potentially of man-made origin (Figure 6c). However touch survey by the diver showed them to be composed of peat. The blocks are from erosion of the peat which underlies the upper clay in the marsh sediment sequence. This layer of peat is revealed on the sea bed as the gravel barrier between Dunwich and Walberswick migrates inland. The peat breaks off in flat failure planes that resemble cut stone faces. Further images of the site are given in Appendix 2, and on the DIDSON films listed in Appendix 1.0.

The DIDSON survey enables us to accurately interpret the Multibeam and Sidescan sonar data for this area, as an exposure of former marsh peat on the seabed which is being eroded by tidal and wave driven currents.

**Figure 6:** Survey site 2, located north of the wreck site (a) in an area of possible ruins revealed on the multibeam data collected in 2011 (b). DIDSON image c) shows square faced blocks but Diver inspection by hand revealed them to be blocks of peat. The multibeam can thus be reinterpreted as an area of peat from the former Dunwich marshes, which is exposed on the seabed and is being eroded by wave and tidal currents.

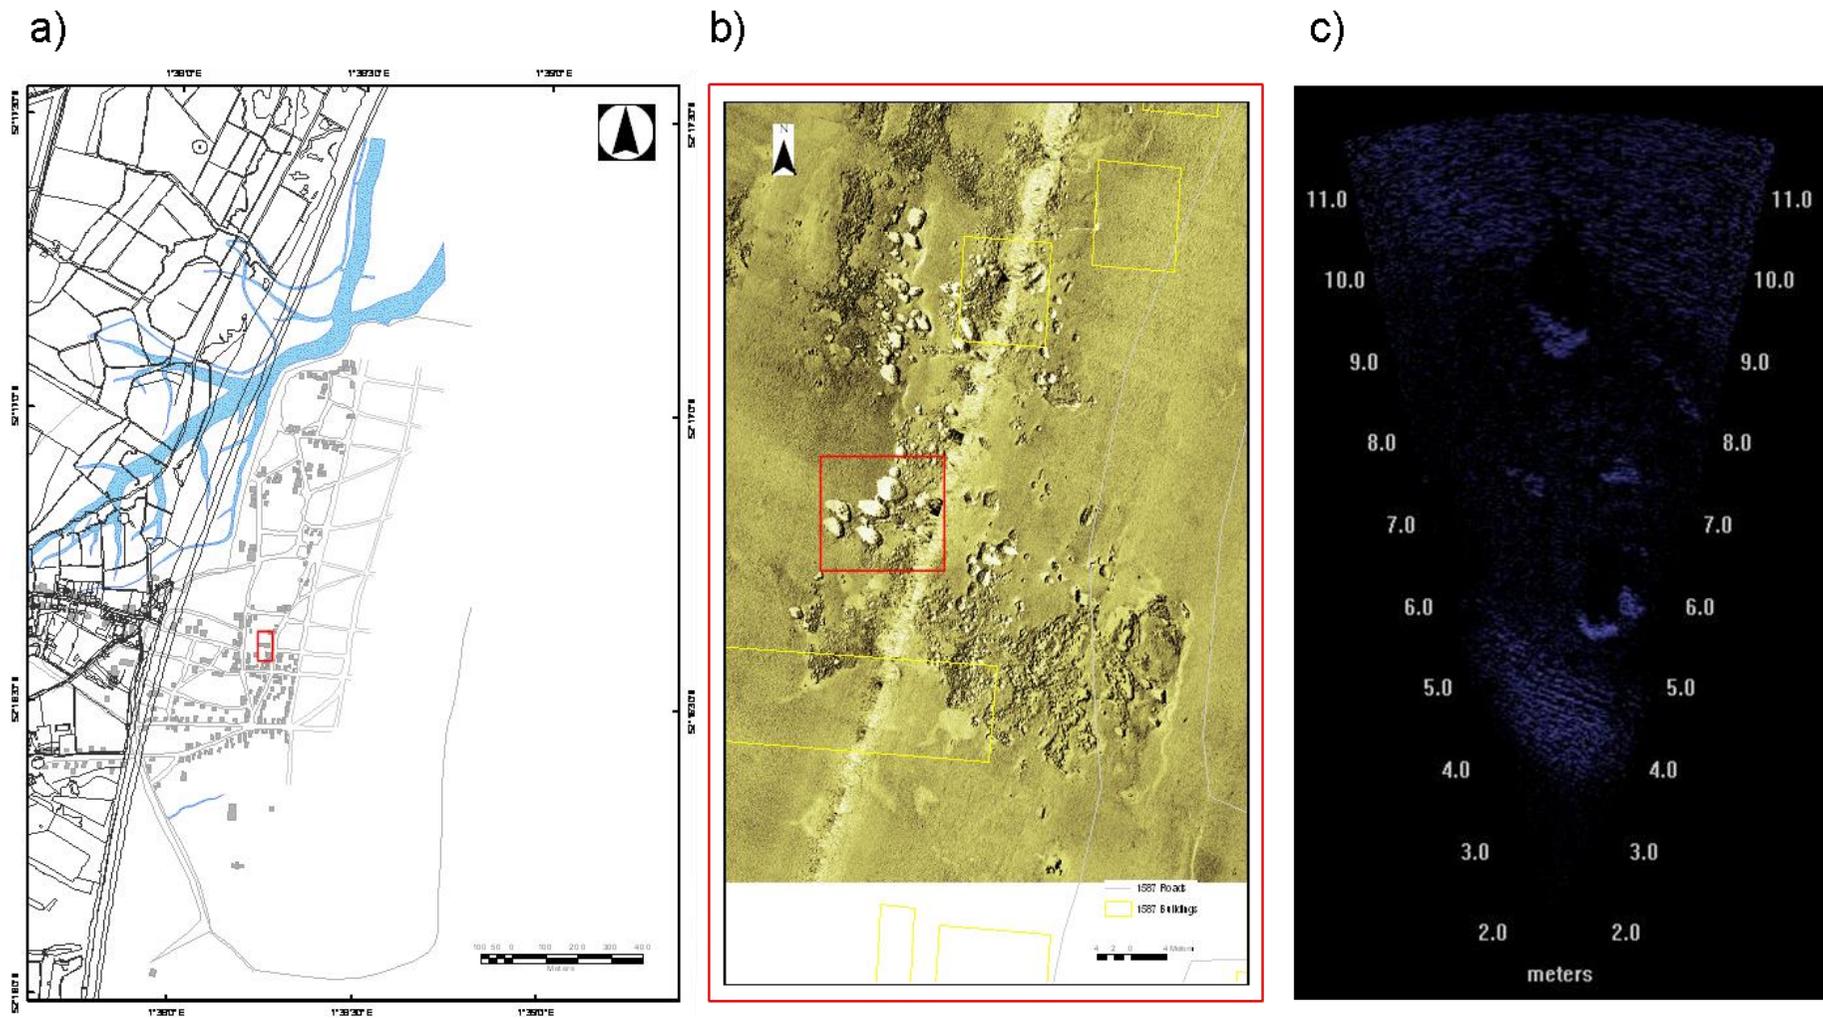
The third target was to have been some unidentified ruins found to the southeast of St Peter's Church which were tentatively attributed to the Toll house since this is mentioned in historic records to have been in the vicinity of the Market place, near to St Peter's church (Gardner 1754). We checked on the ruins of St Peter's using the DIDSON to confirm the sidescan sonar survey which suggested that sand had moved over the town site, burying many of the ruins that were visible in previous years. The ruins of St Peters church (see Figure 7a,b) were located on the sidescan sonar and a shot line put down on the GPS coordinates. The diver then undertook a DIDSON sweep on the seabed around the shotline. The ruins (Figure 7c) were barely visible above the sand, protruding only some 0.2-0.3m (diver estimate based on touch). Between 2008 – 2011 these ruins had protruded up to 1.2m above a firm seabed. This confirmed that the site has been buried under c. 1m of sand, and therefore explained the absence of smaller ruins in the sidescan sonar data. Further images of the site are given in Appendix 2, and on the DIDSON films listed in Appendix 1.0.

**Figure 7:** Survey site 3, St Peter's Church located in the centre of the former town (a) was the largest area of ruins with large blocks associated with the tower in 2008-2011 surveys – 2009 Sidescan sonar data shown in (b). DIDSON image (c) shows flint and mortar blocks that Diver inspection estimated at 0.2-0.3m above a sandy bed. Rippled area of sandy bed can be seen, together with scoured depression created by tidal current interaction with the ruins.

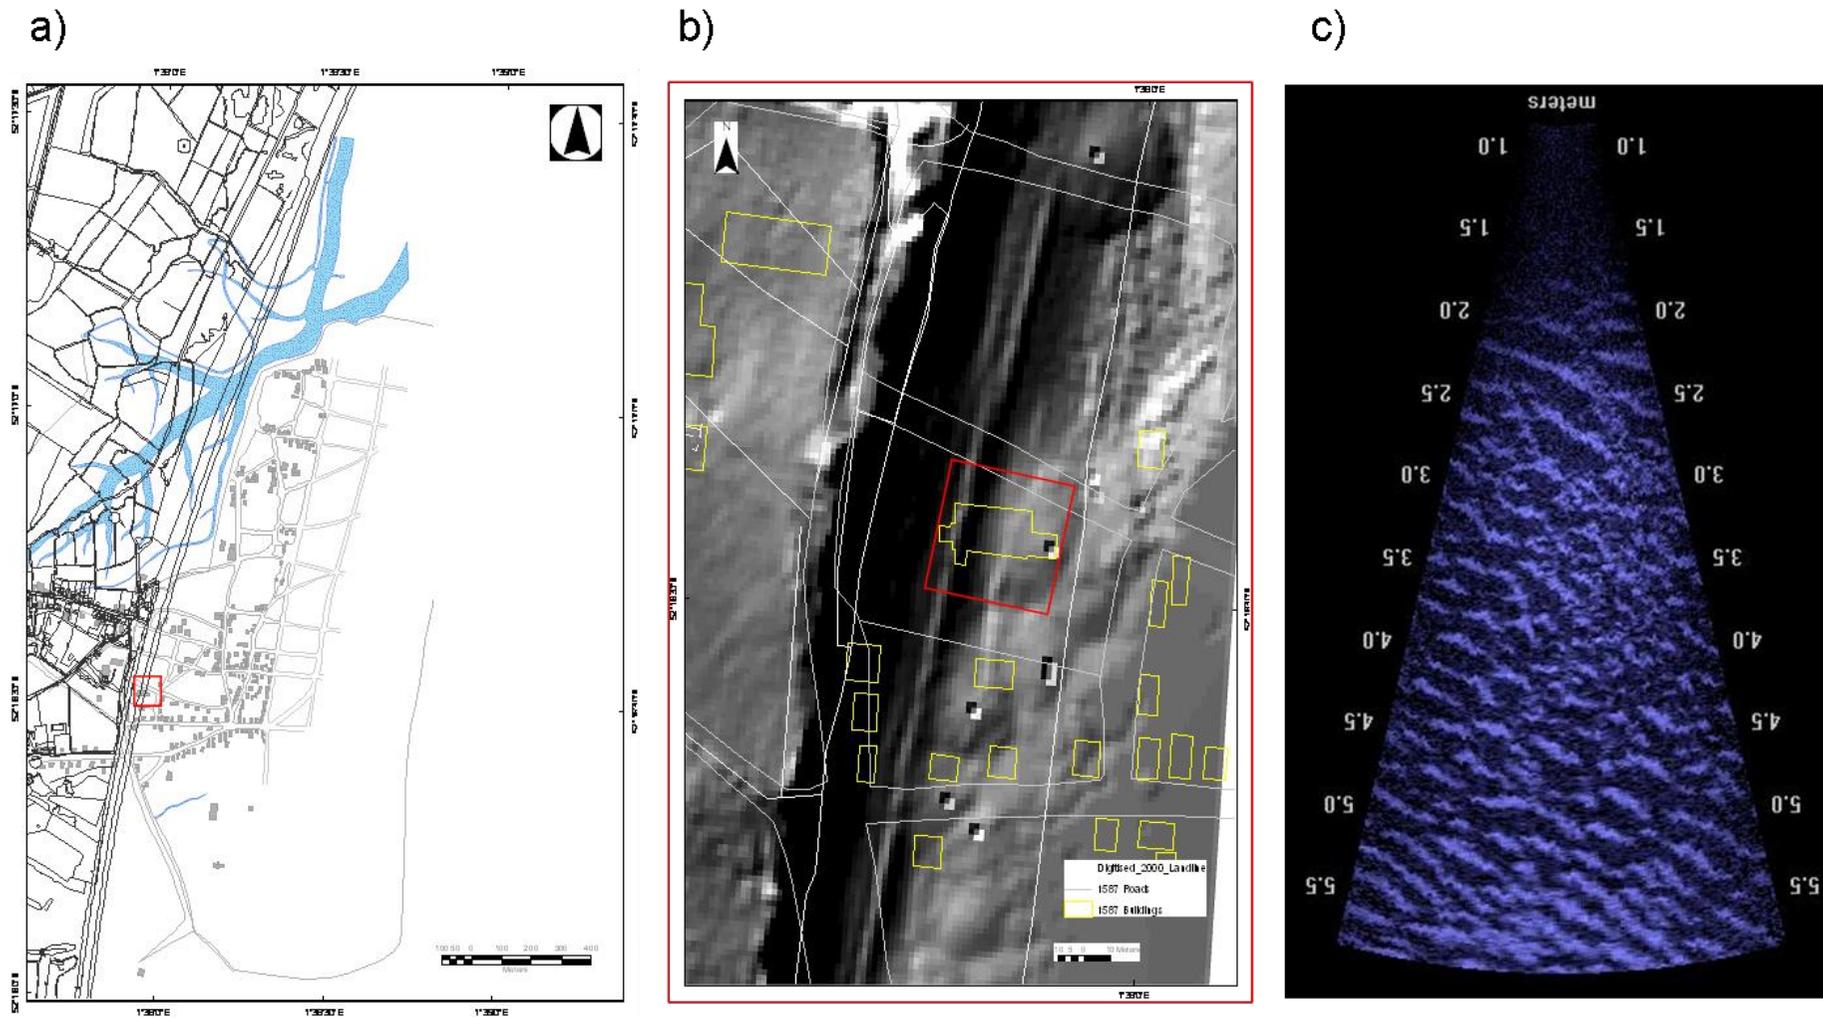
The fourth target was All Saints church, which collapsed over the cliffs between 1880 and 1923 (Sear et al., 2012). The site was extensively dived by Stuart Bacon and others during his survey of the site in 1973-1983 (Bacon & Bacon 1979; Bacon 1979; 1983). Bacon described the ruins as lying in a gully between the beach and the inner sand bank with large sections of the tower and areas of flints scattered over the bed. This gully lies immediately off the beach and is too shallow for boat access and sidescan or multibeam survey (Figure 8a,b). This provided an ideal target for DIDSON-DH as it can be accessed from the beach using a tethered free swimming diver. We identified the site using GPS and cliff markers (gravestones near the cliff edge denote the former graveyard of All Saints). The diver then swam out over the gully (which runs parallel along the beach) and drifted down across the site scanning the seafloor. The seaward (western) side of the gully is formed by the inner sandbank. DIDSON images (Figure 8c, Appendix 2) shows a sandy bed with ripples running at an angle up the face of the inner bank. In contrast, the bottom of the gully and the landward (east) toe of the beach is formed of gravels (Appendix 2). There was no evidence of any ruins protruding above the surface of either beach or sand bank. Some large stones were evident in patches in the bottom of the gully which may be derived from the ruins of the church, but this is speculative. The DIDSON survey confirms that the ruins of All Saints church are currently buried under the beach and inner sandbank.

**Figure 8:** Target 4 survey site of All Saints Church located in close to the current beach (a, b). DIDSON survey revealed that the site is currently buried under the beach and inner sand bank with not evidence of any ruins within the gully area. The landward (west) face of the inner sand bank is strongly rippled (c).

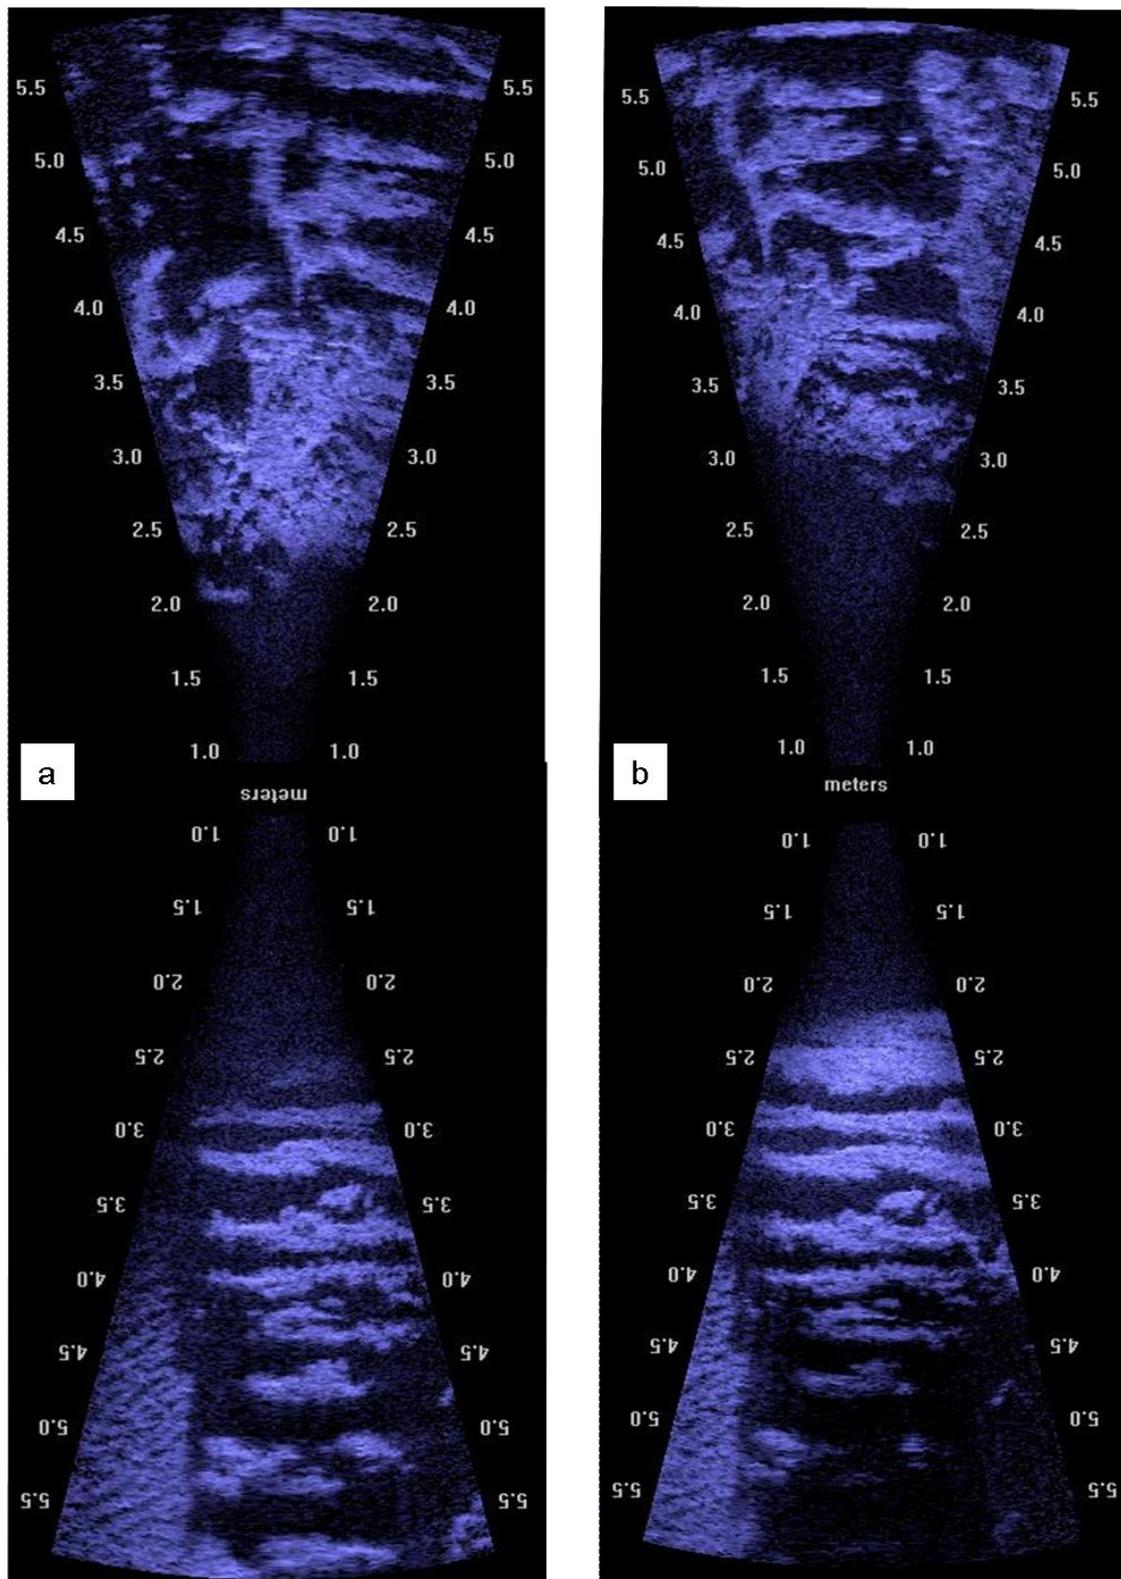
**Figure A1:** Wreck site mosaic. Diver stood in the centre and did a 360 scan. These two mosaics of two DIDSON screen shots are looking along the axis of the vessel (SW-NE). Ribs can be seen in the bottom half of the image and the top half together with ballast / cargo stones scattered around the upper (northern) part of the vessel.

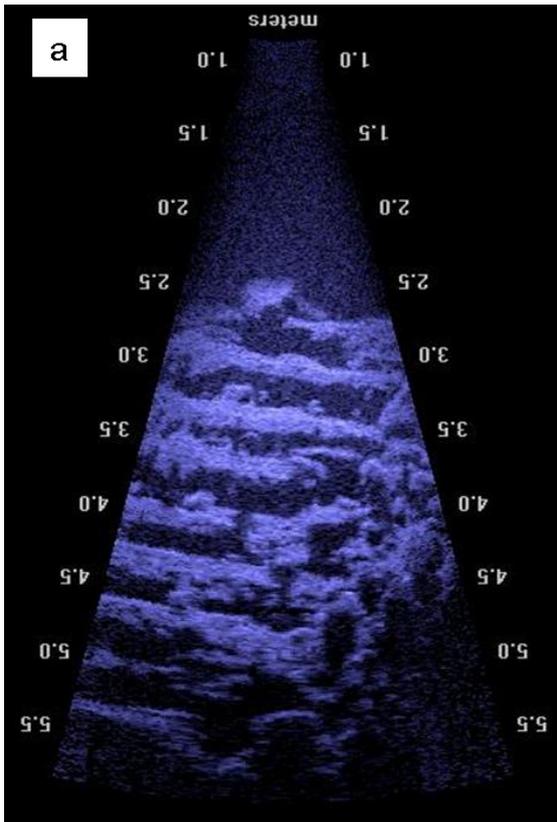
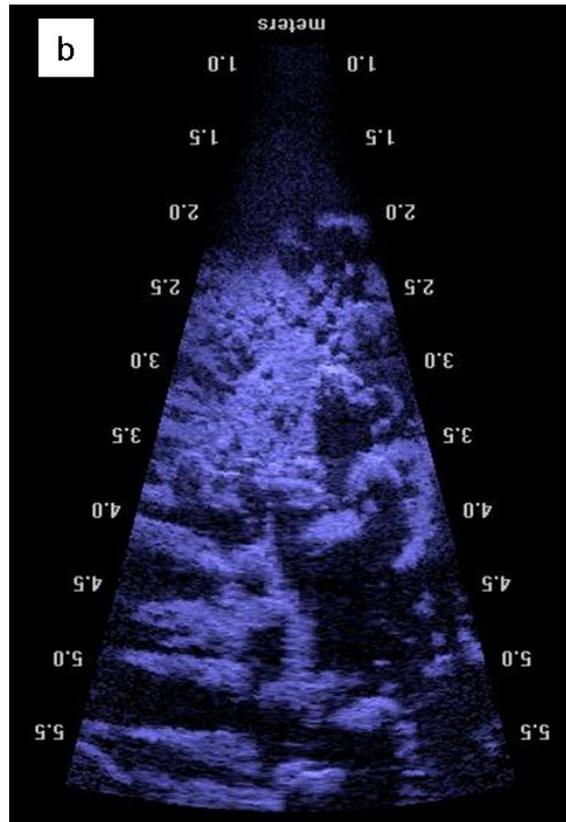
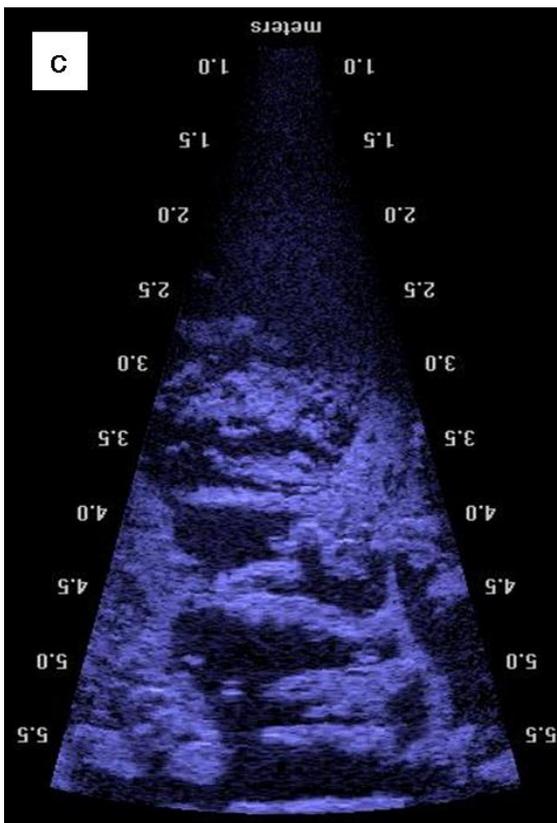
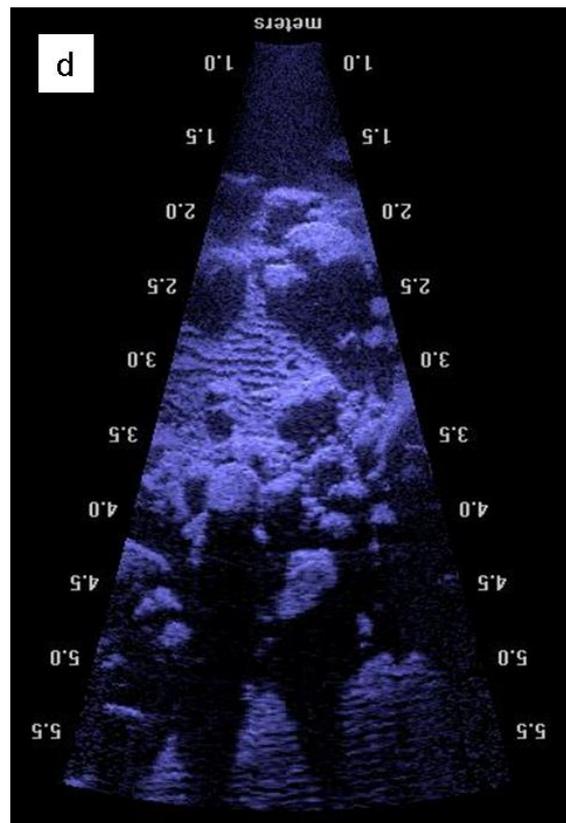
**Figure A2:** Wreck site a & b) Ribs clearly visible with ballast/cargo stones scattered over the site; c & d) shows ribs and larger (up to 0.35m) stones (cargo?) with sand ripples of the surrounding seabed (d)

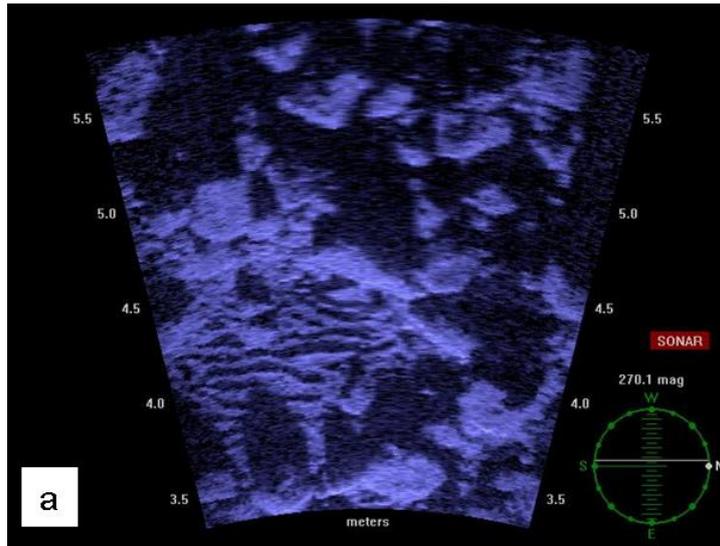
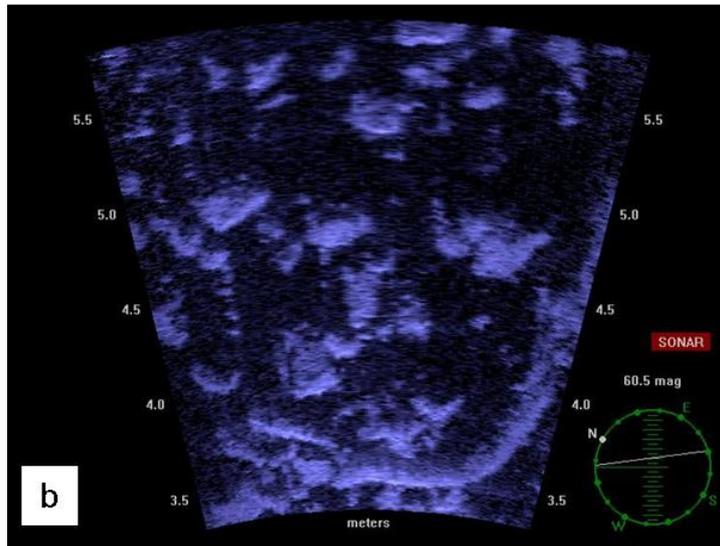
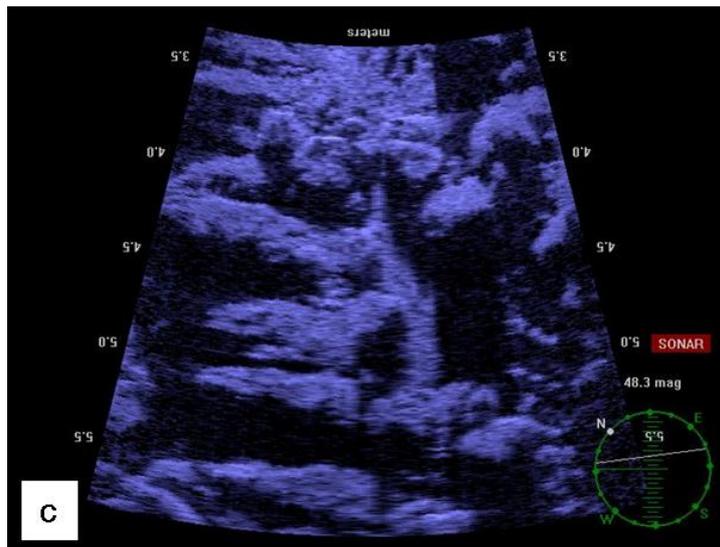
**FigureA3:** Wreck Site at higher resolution (3.5-5.5m) showing a) scattered stones with rippled sand bed. B) shows a curved rib (right of image) lying over stones. c) Shows detail of wooden ribs with ballast/cargo of stone lying over them. Ribs are approx. 0.25-0.3m width.

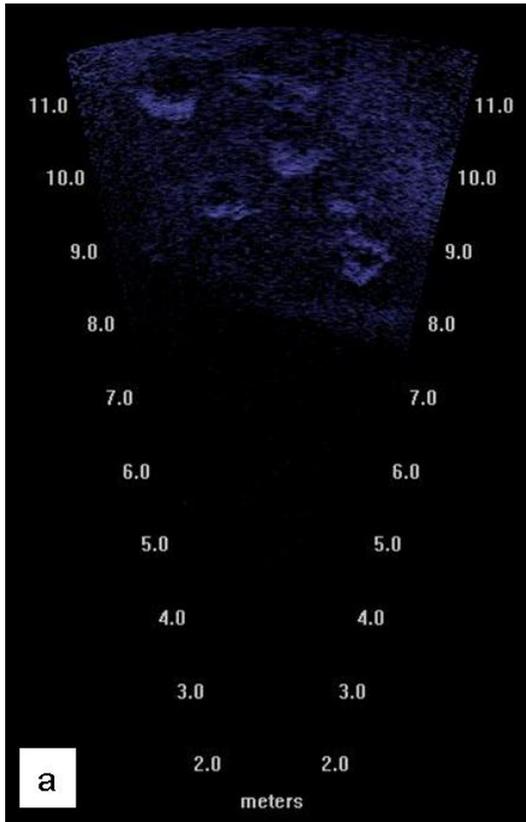
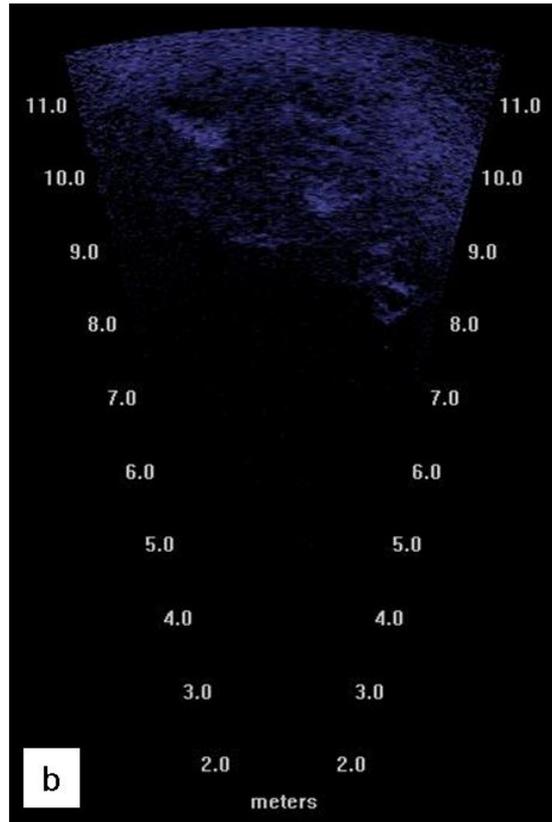
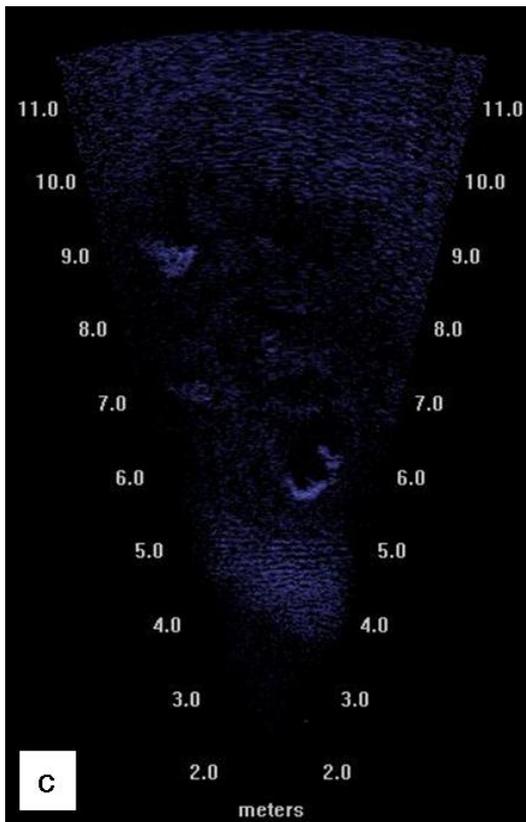
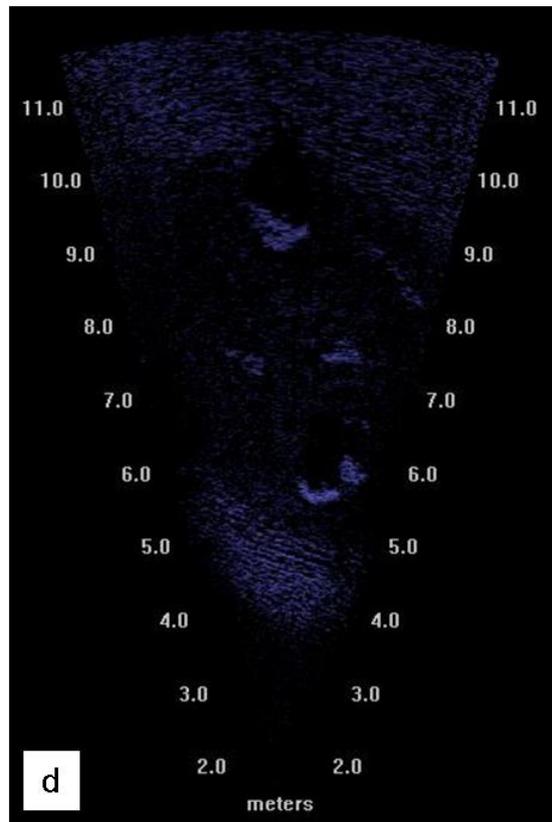
**FigureA4:** St Peter's Church site showing the tops of larger masonry blocks from the region of the tower. The sea bed is mainly sand and silt washed into rippled. Clocks have generated a depression through tidal scour around the blocks (Sear et al .,2012).

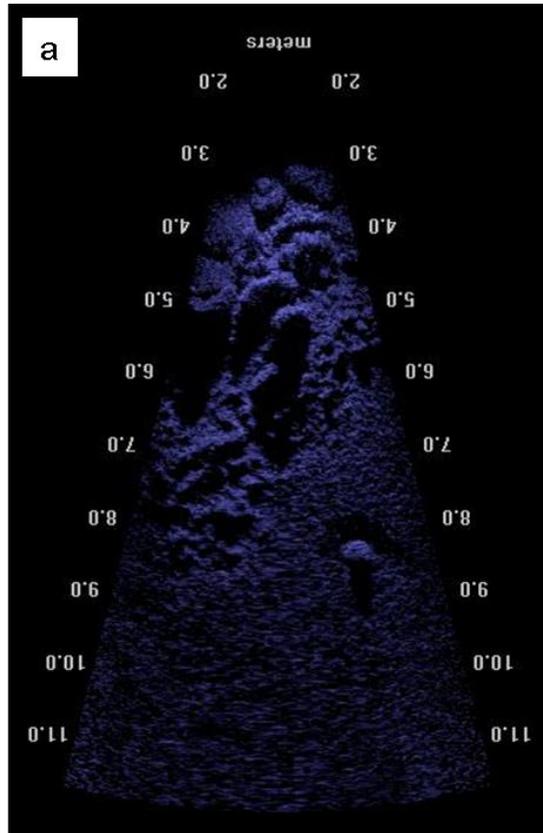
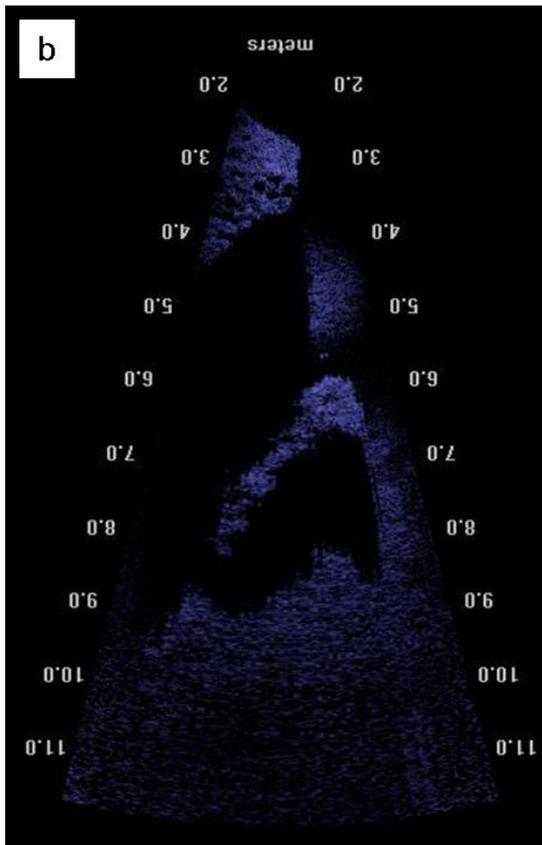
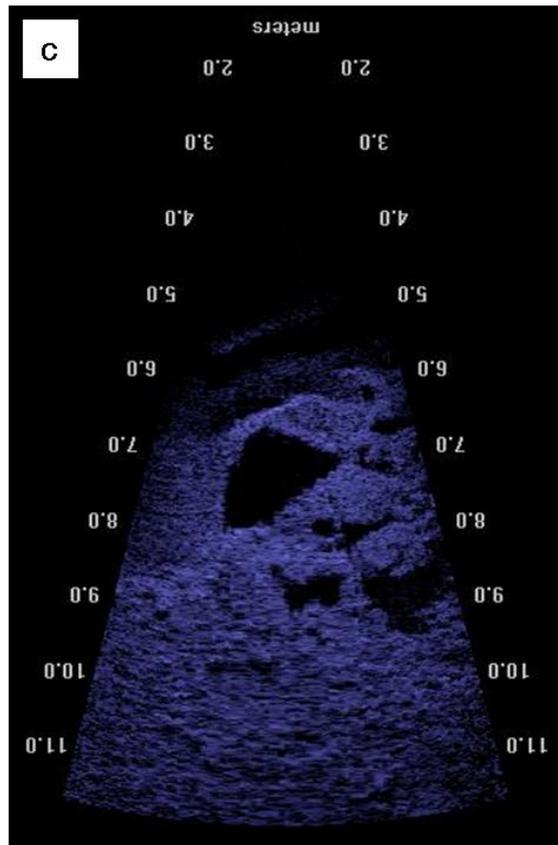
**FigureA5:** Peat blocks and eroded peat surface exposed on the sea bed. Coastal recession of the gravel barrier over the marsh sediments scours off the top of the marine clay revealing the lower peat layer in the seabed. The peat breaks off into flat faced blocks that are sometimes washed up onto the beach. Figure b) shows acoustic shadows cast by large blocks. c) shows a square faced series of peat blocks.

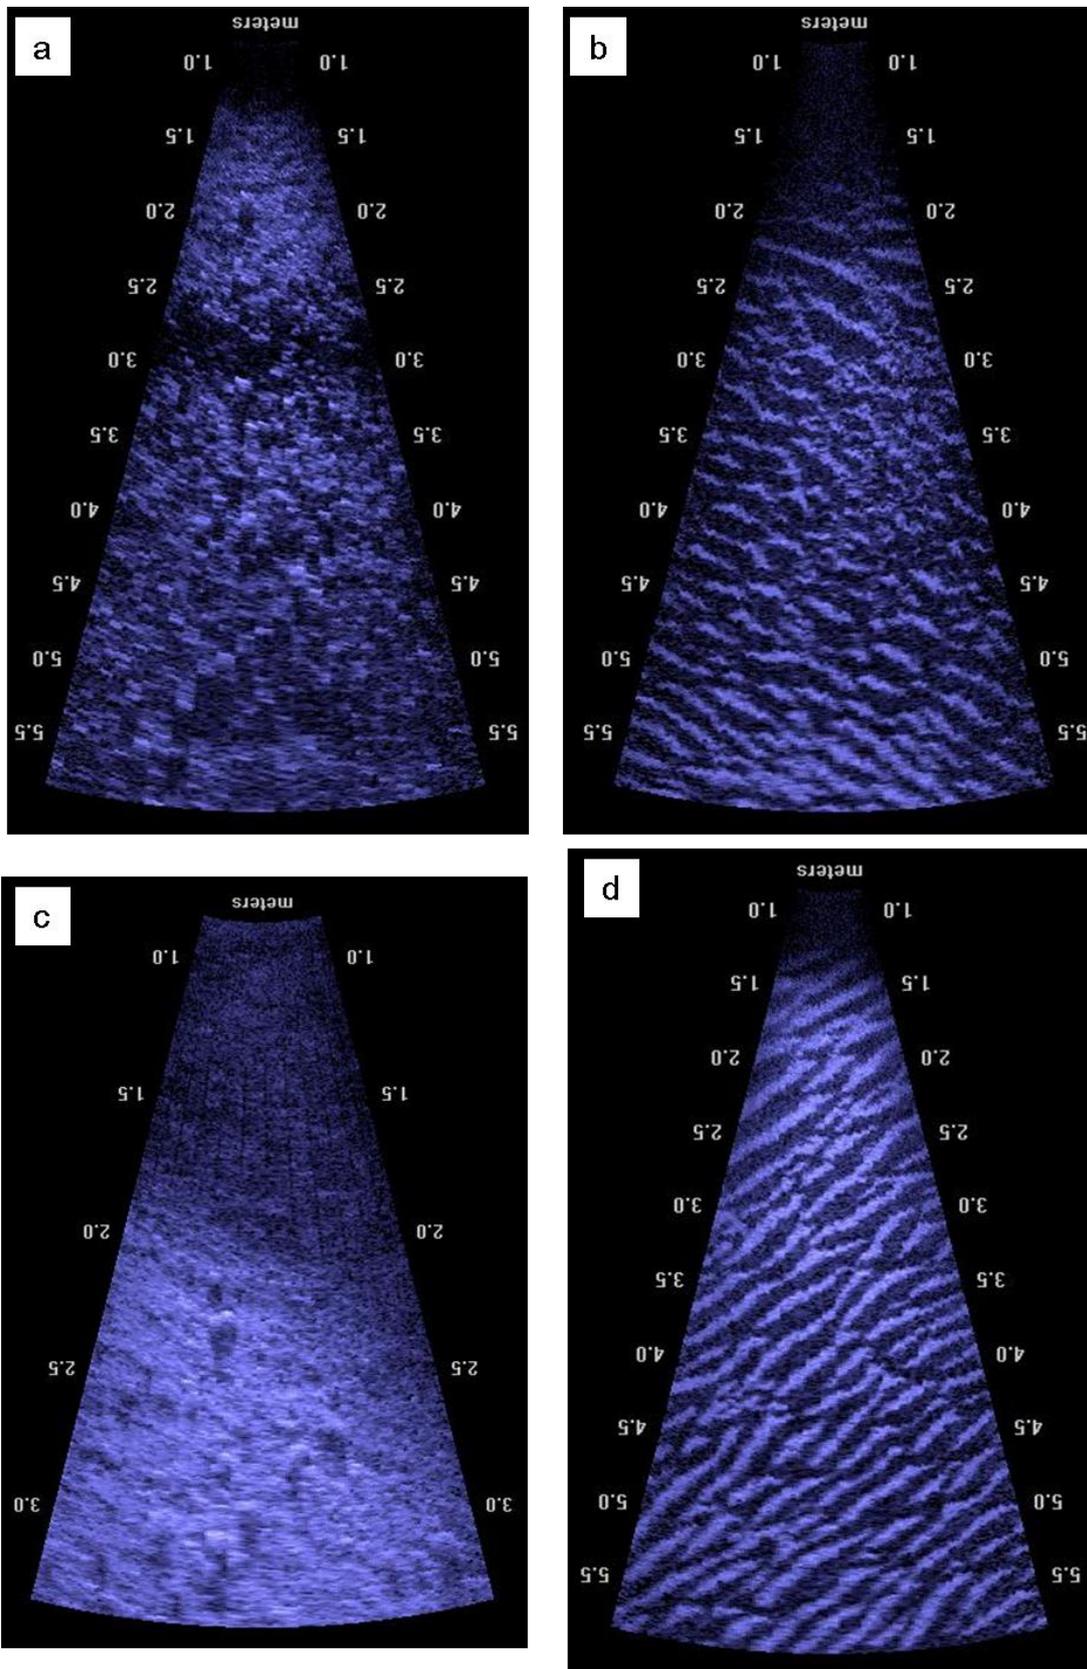
**FigureA6:** All Saints Church site. a) Is looking shoreward (West) onto the lower beach and shows a gravel bed with at 2.5m a low berm. C) Is a view along the gully bottom parallel to the beach. Larger flints probably from decay of All Saints church can be seen. B) and c) are looking seaward (East) along the inner sand bank that borders the gully. Gravel being covered by sand ripples (b) and sand/silt ripples (d). No sign is evident of any ruins from All Saints demonstrating how ruins exposed in the past, (Bacon 1979) are rapidly buried under the beach and inner sandbanks.
