**Touching The Tide Project Report**  
**Dunwich Marine Archaeology Survey**

Professor David Sear

Department of Geography & Environment  
University of Southampton  
2015

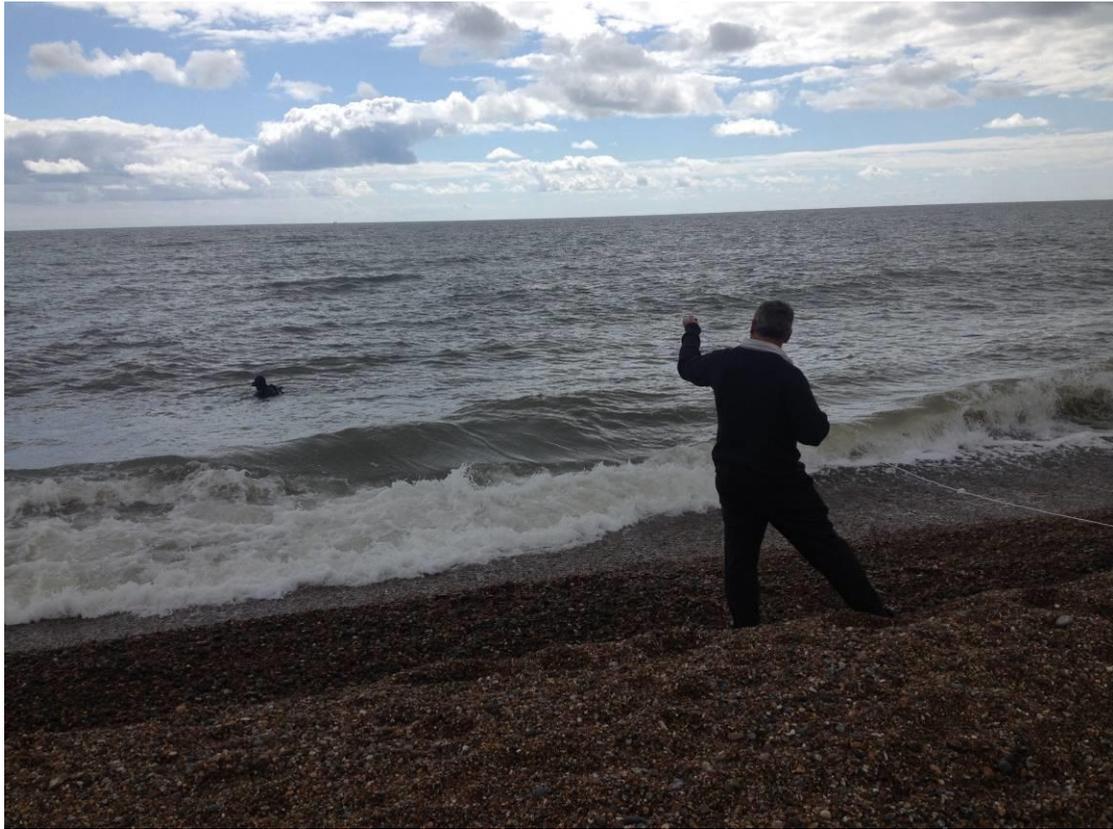
**Figure 3:** Surveying the site of All Saints church from the beach using a tethered safety line and DIDSON-DH sonar. Diver Andy Rose, Dive Master Duncan Coles. Bacon (1979; 1982) reported in a large section tower lying across the ruins in a gully just off the beach around where the diver is located in the photograph.

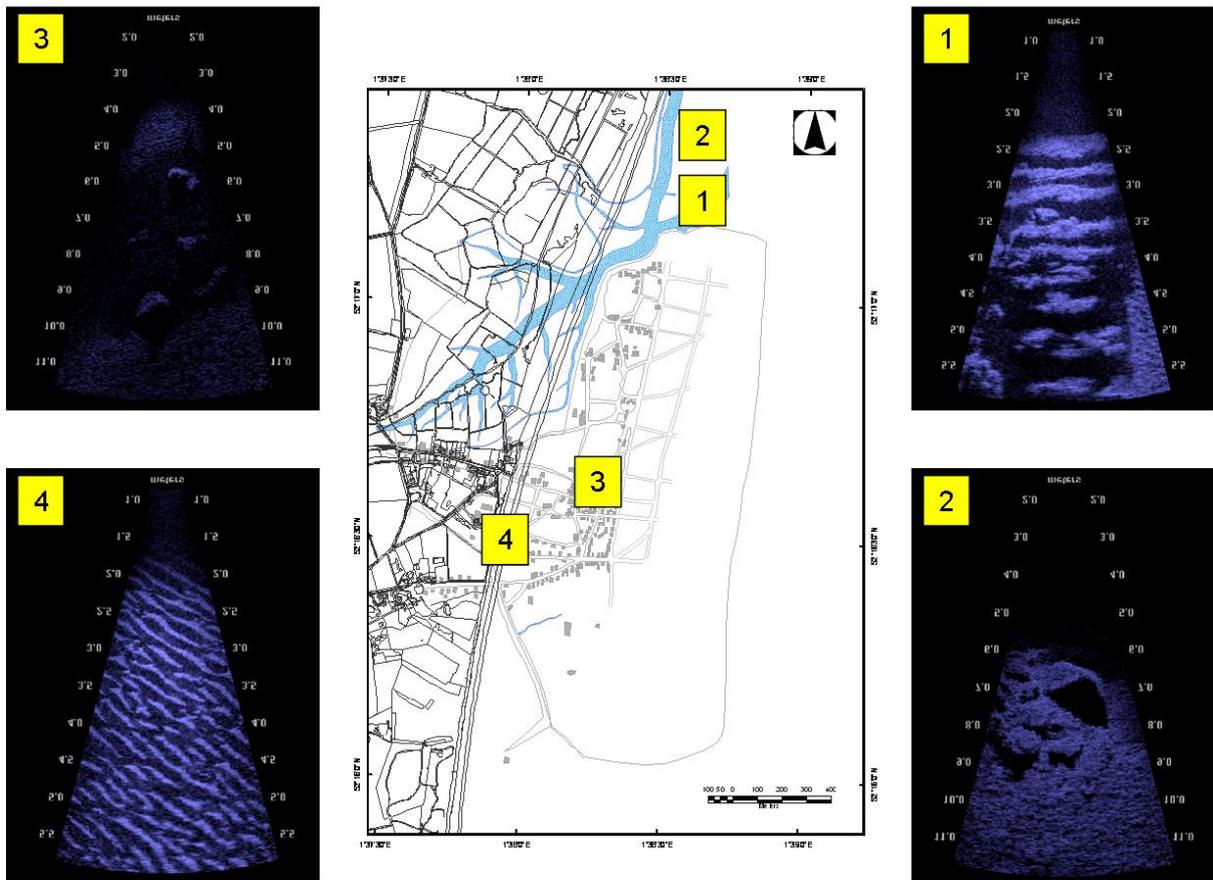
**Figure 4:** Survey sites identified for DIDSON sonar survey. Site 1 was a possible wreck site, Site 2 was a series of possible cut blocks associated with the harbour. Site 3 was located near to St Peters (shown in DIDON image) but was identified as the toll house. Site 4 was the site of All Saints Church and was accessed from the beach.

Further to the north of the town in the region of the old harbour, the seabed was not covered in sand, and we were able to locate the two targets of interest (See Table 1 and Figure 4 above).
